Appraisal report.

Runabout Typhoon replica.

Owner Mr. J.Hurley.

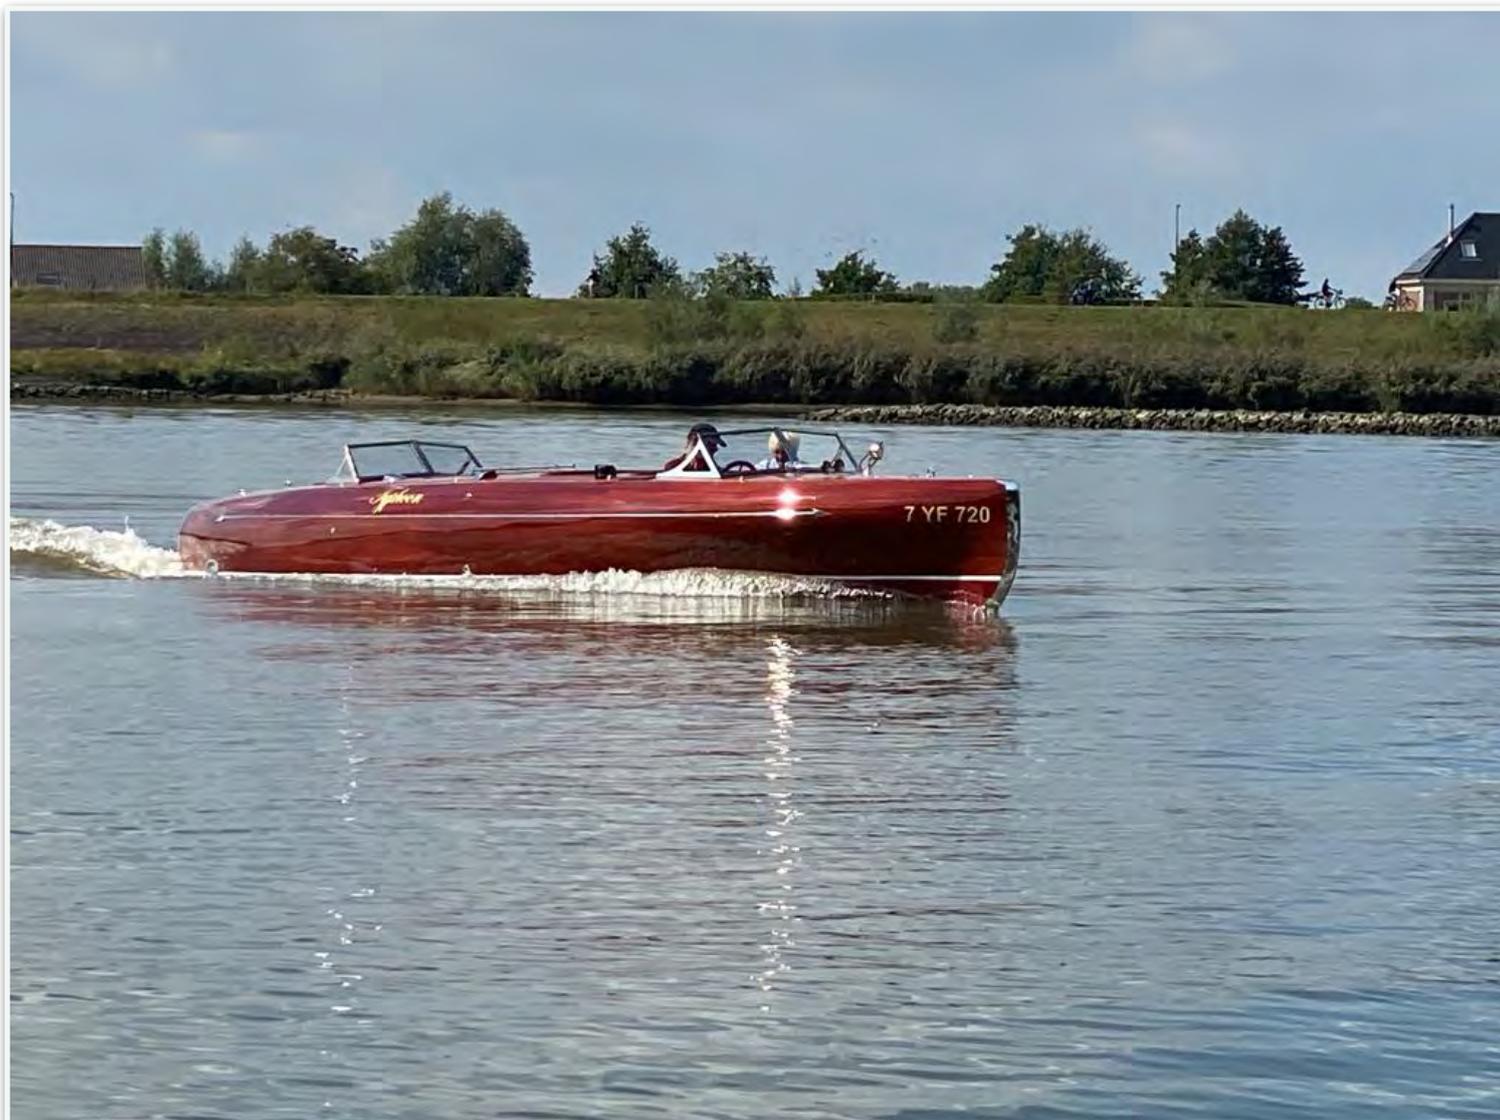
Overview appraised vessel.

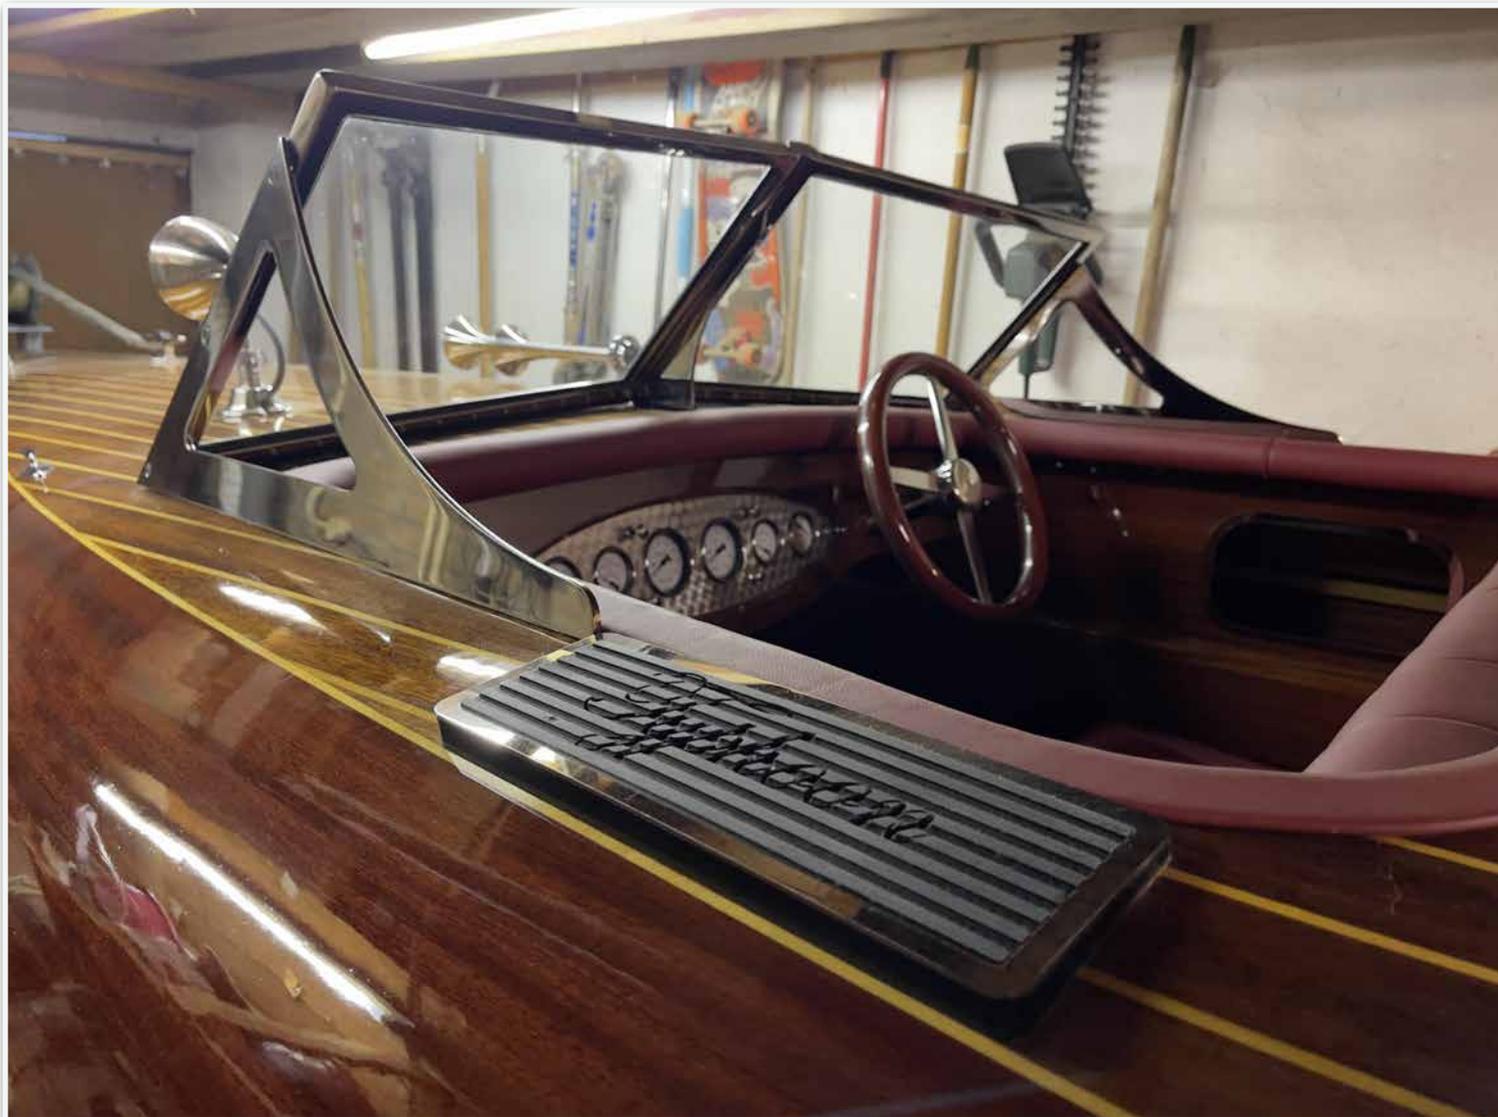
Dashboard with steering position.

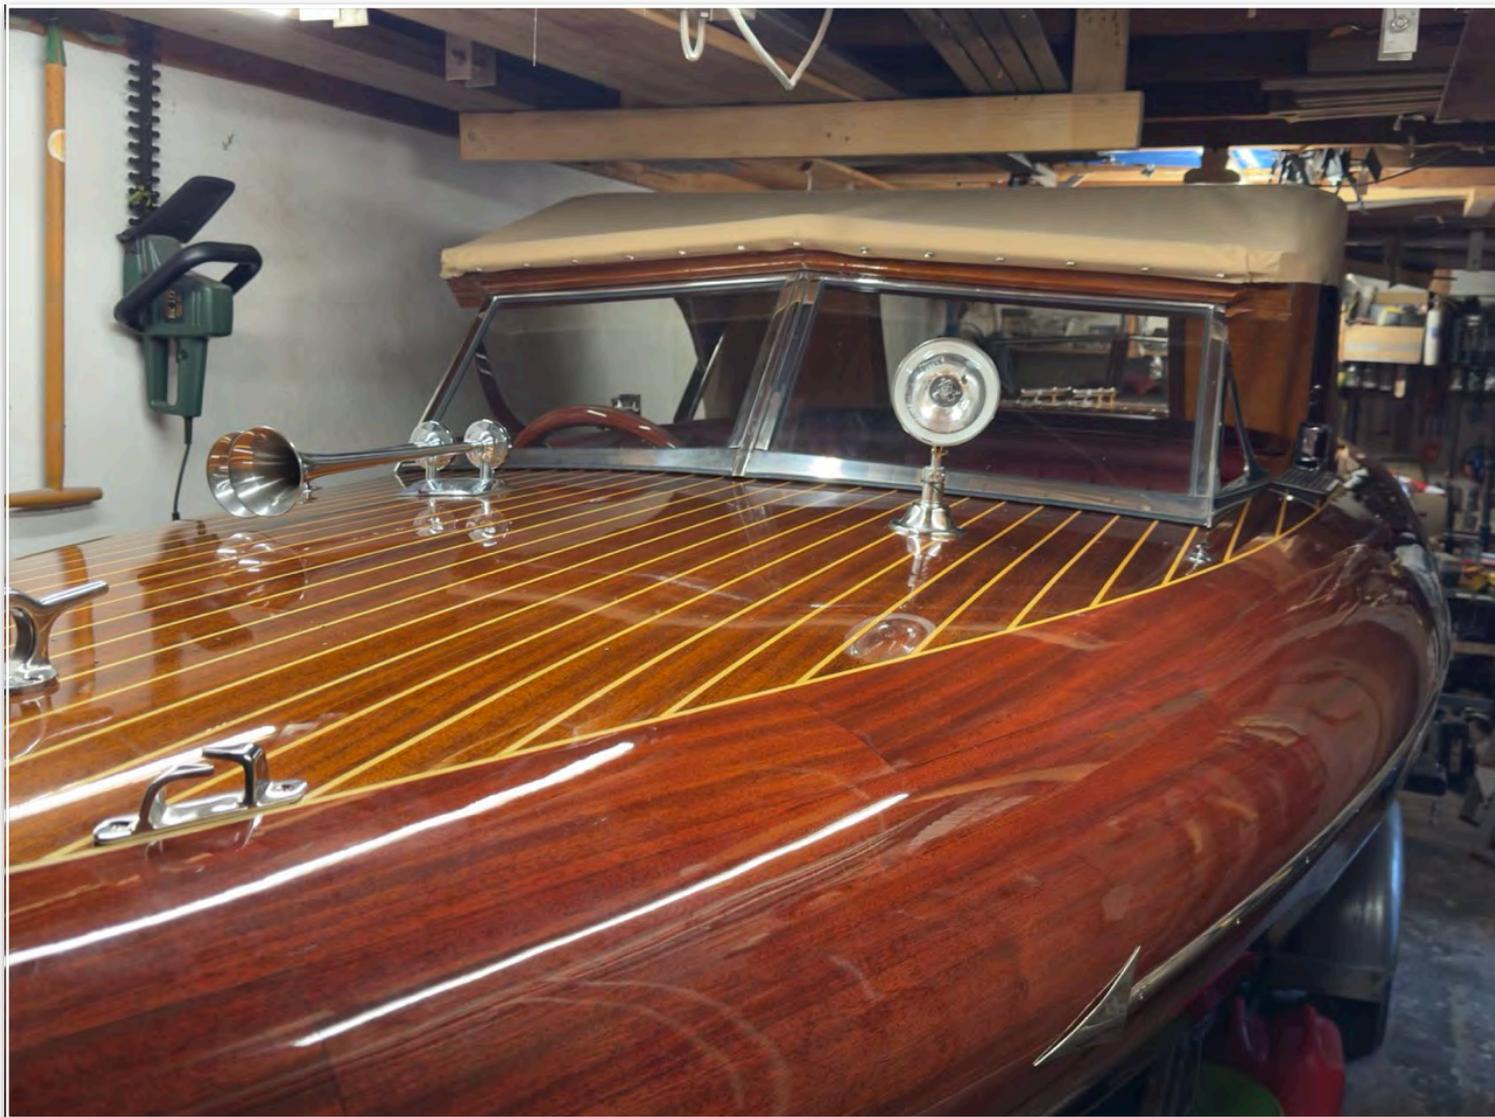
Convertible top which can be completely folded away and thus hidden from view.

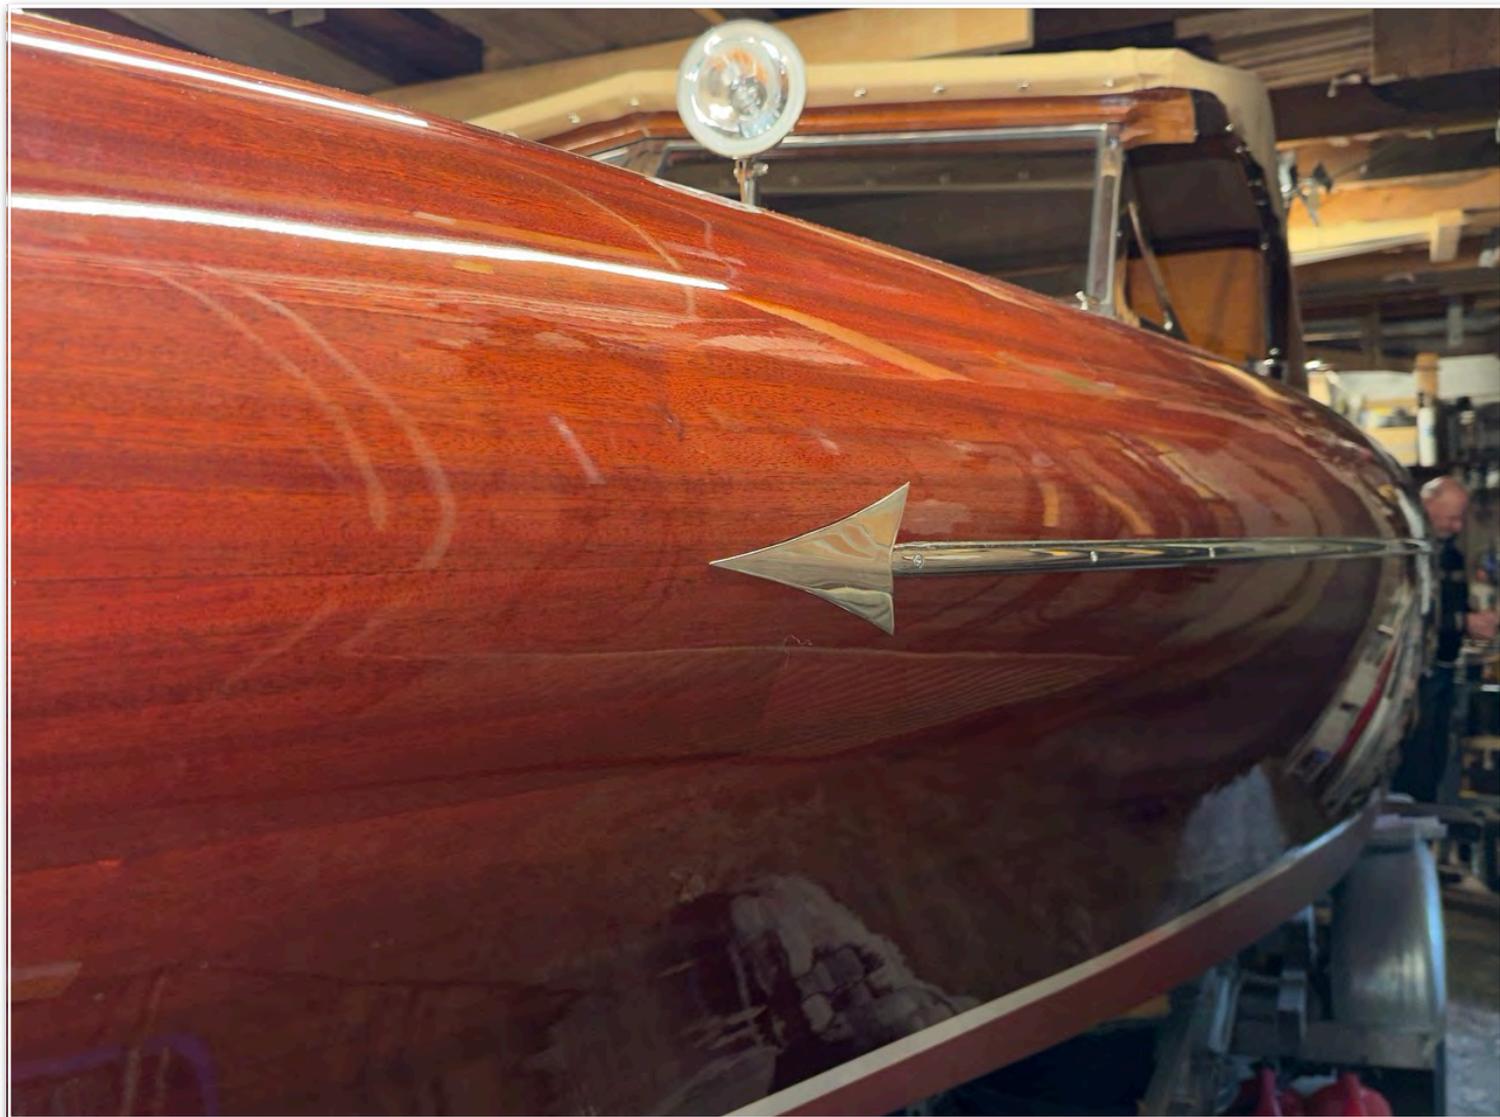
Lacquerwork finished with finesse.

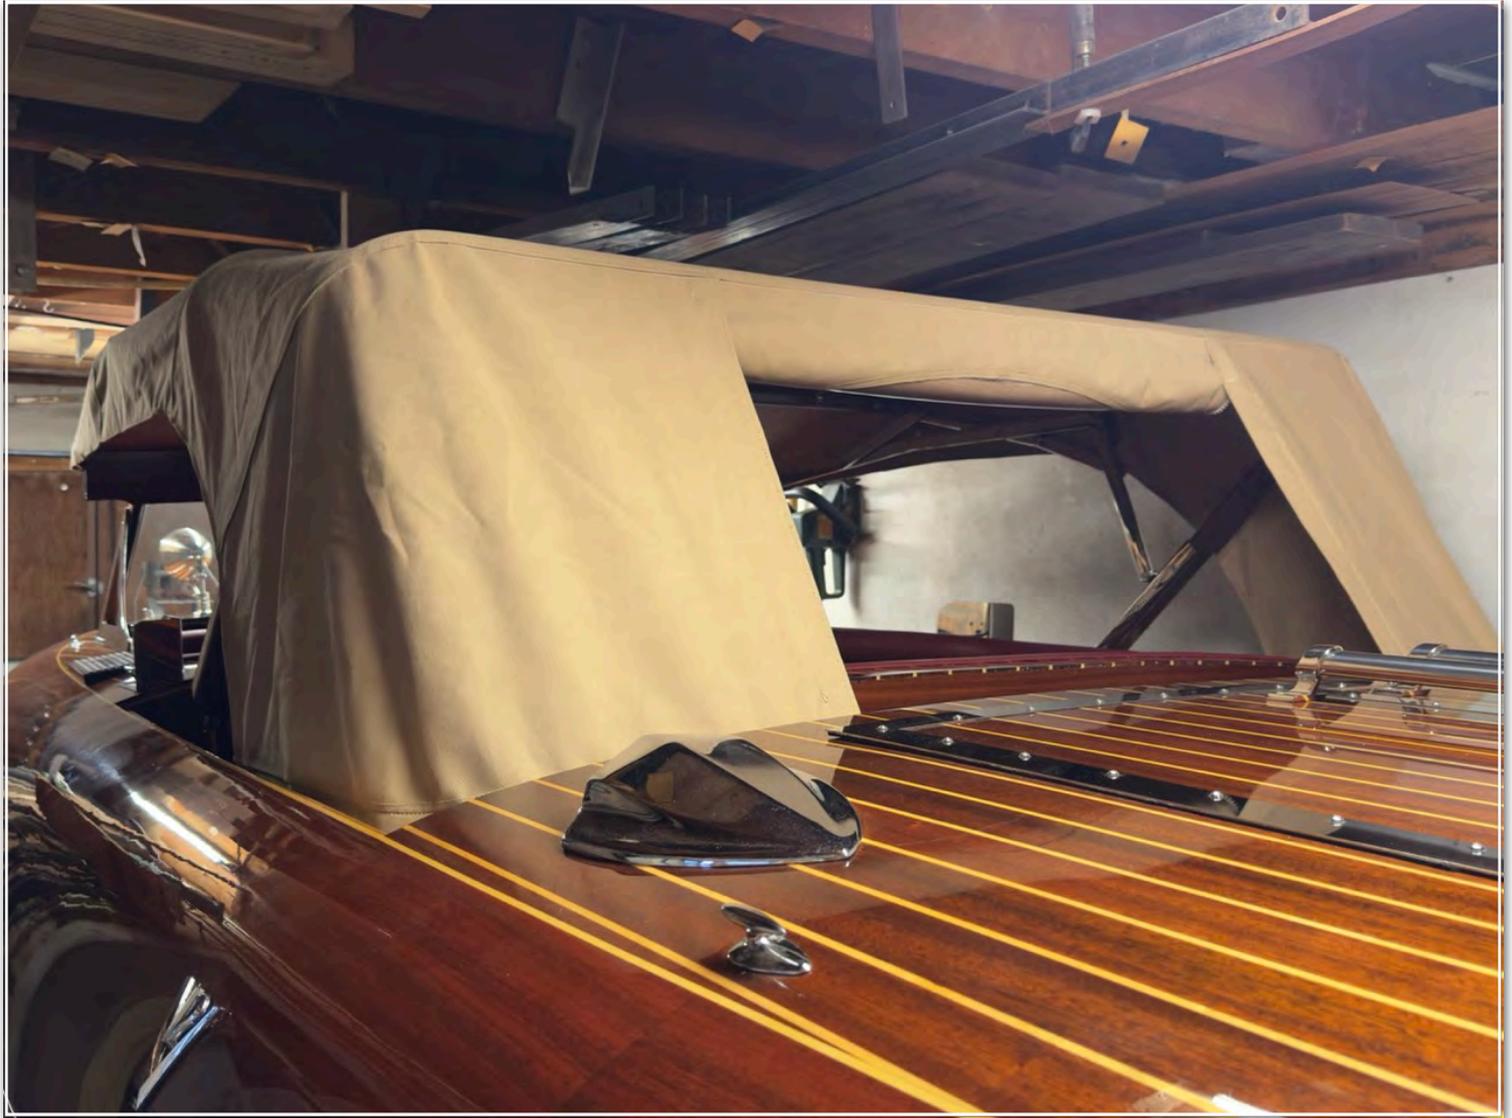
Convertible top with (rolled up) back screen.

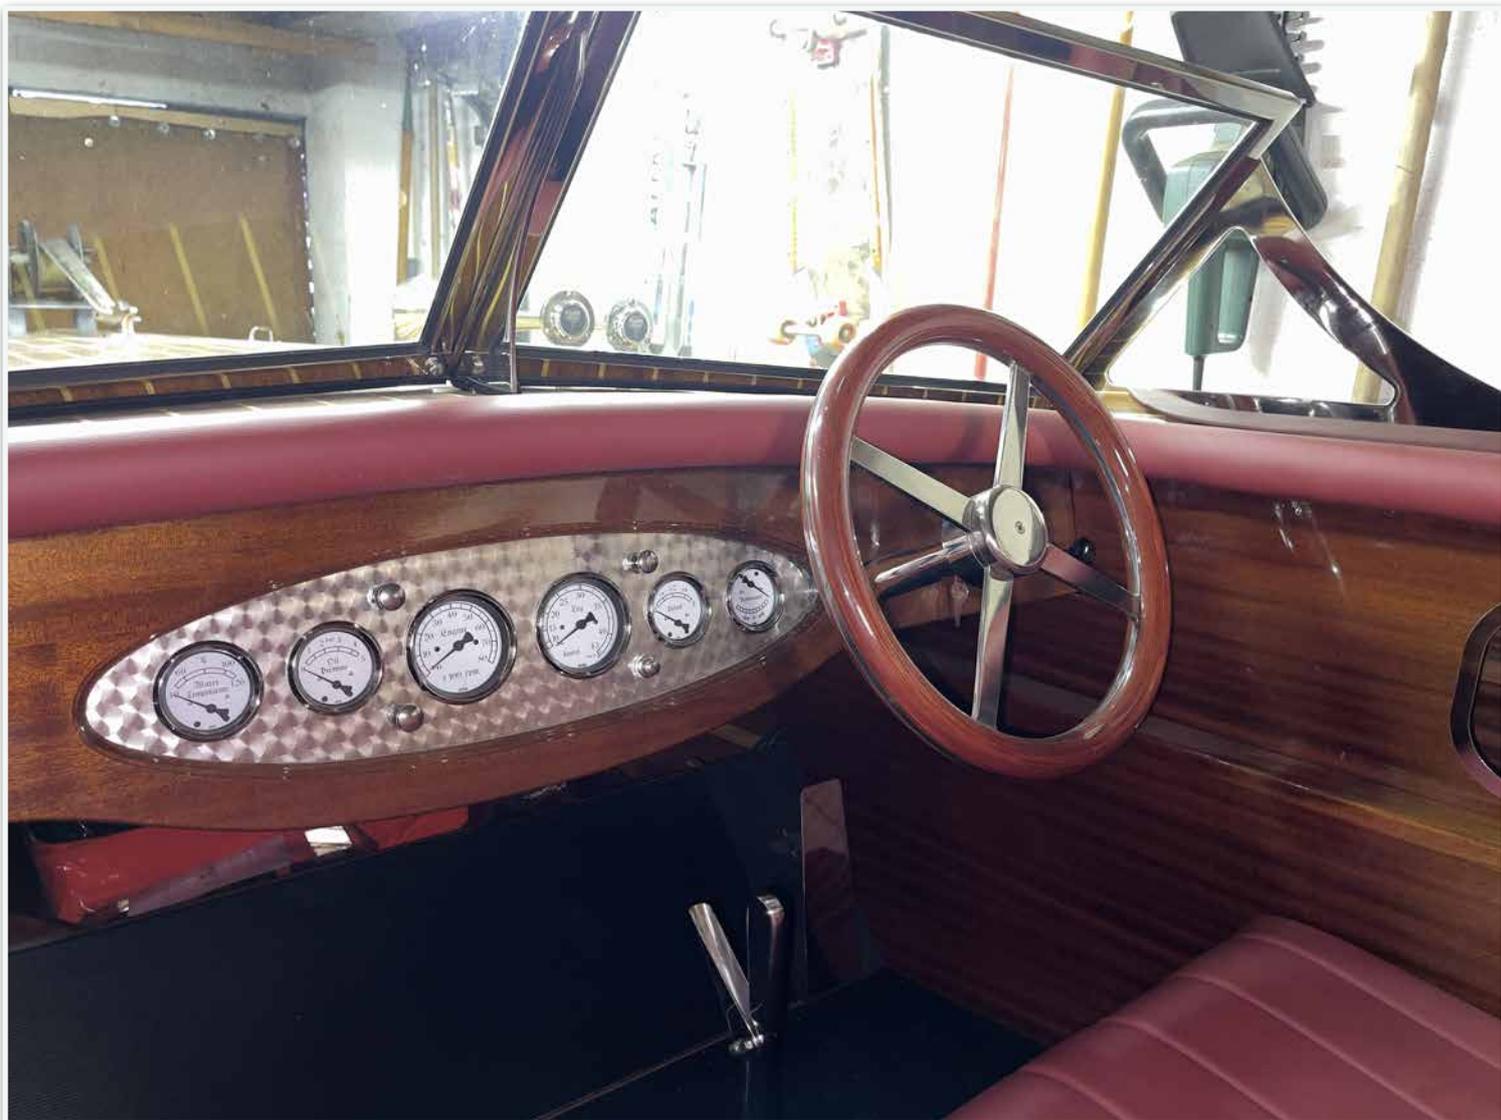
Dashboard with steering position, lever for gearbox and pedal for engine control.

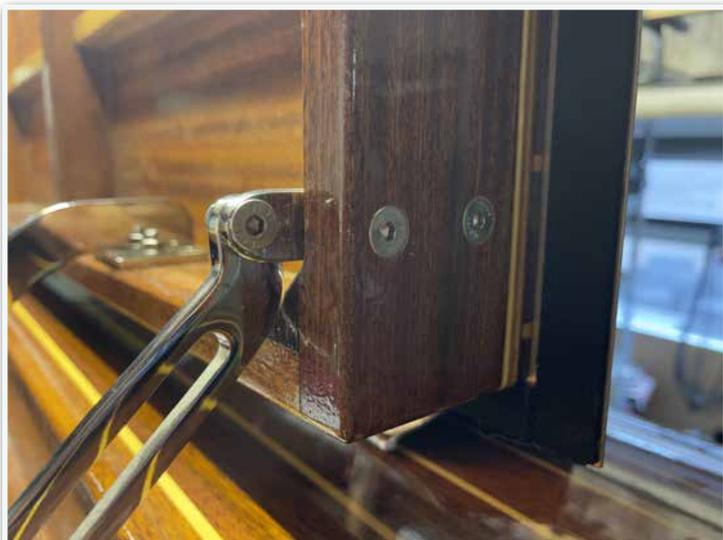
Rich amount of details, engine compartment access hatch.

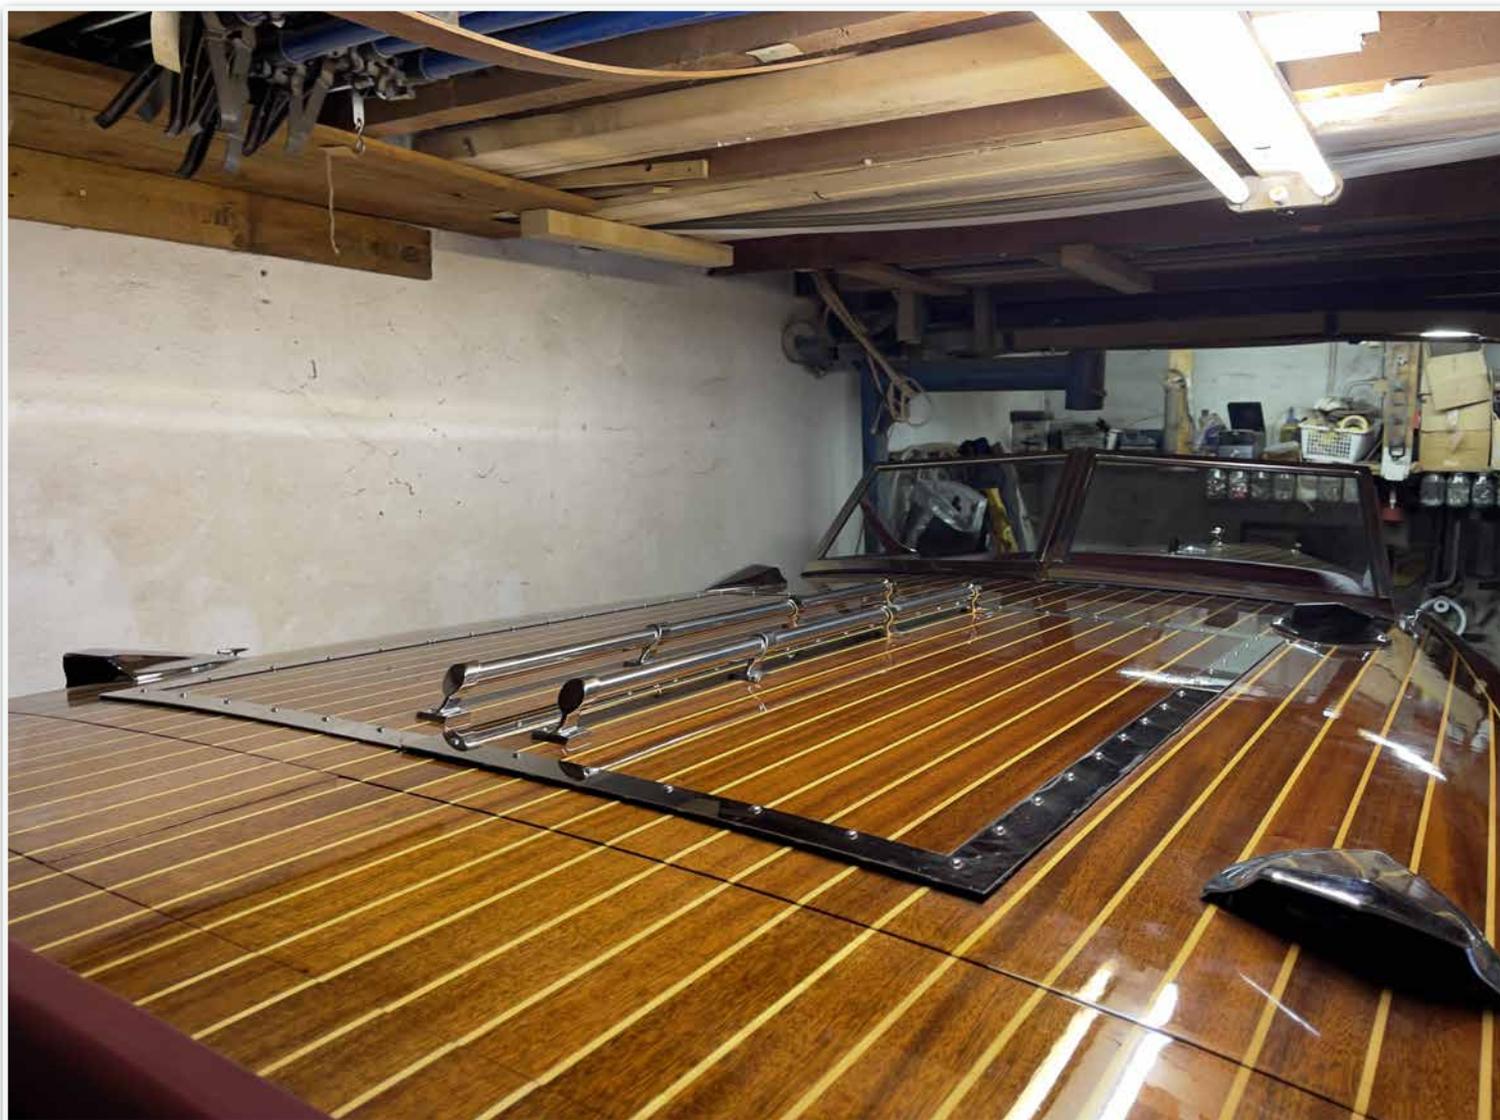
High level of finish varnish.

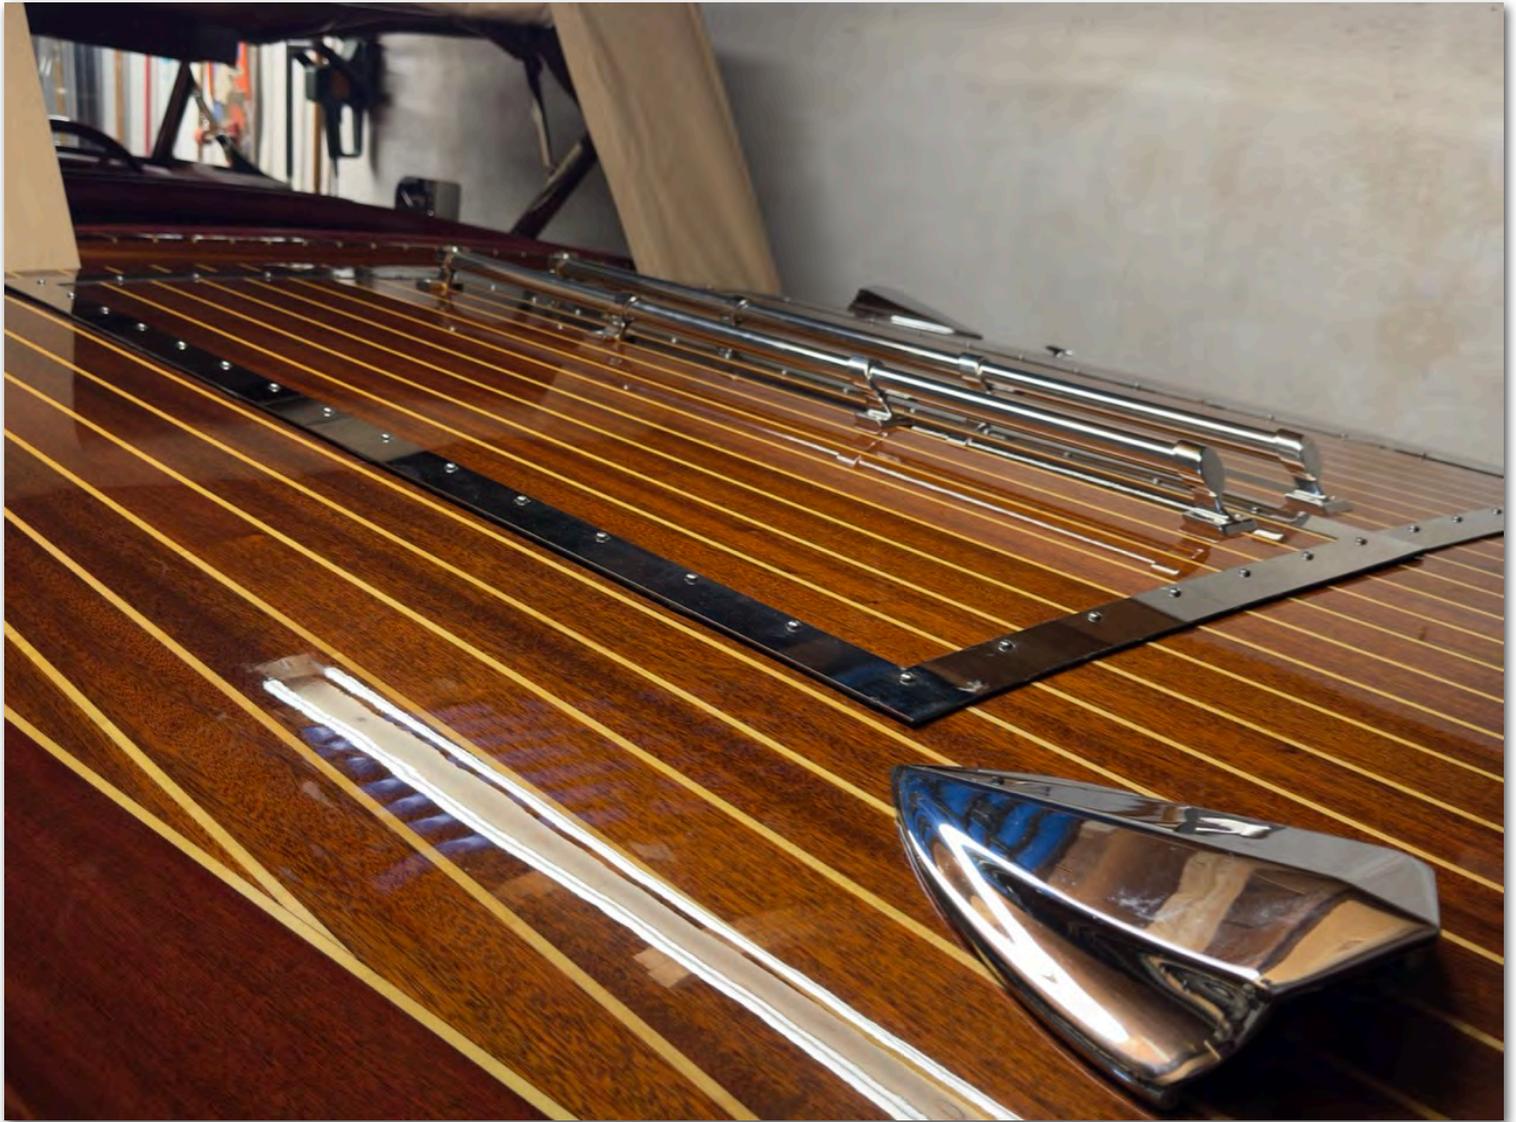
High level of finish varnish, rich amount of stainless steel details.

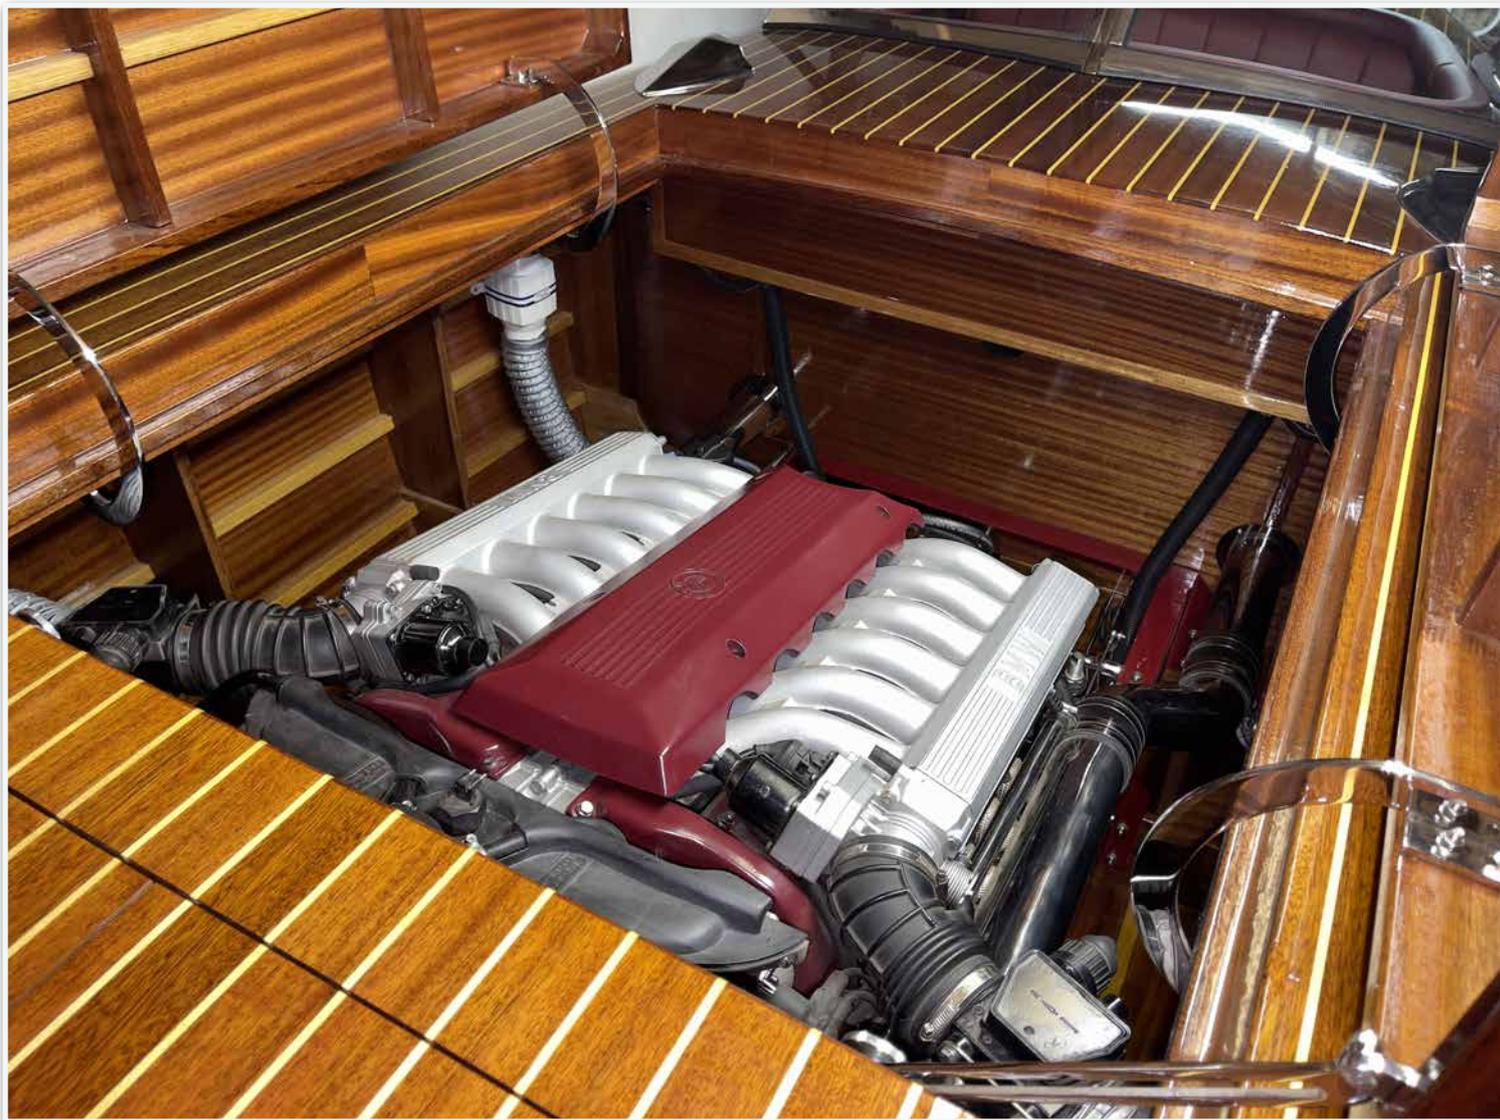
BMW V12.
